Mercury Flooring The Hidden Dangers and Potential Solutions

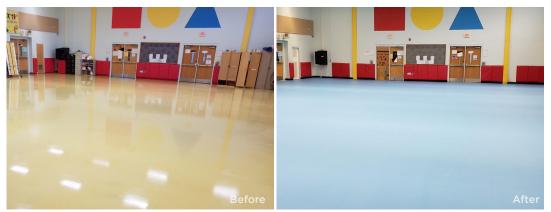
VHB worked with the New Jersey School Development Authority (NJSDA) to evaluate the potential presence of mercury-containing floors in local school district buildings. Once suspect flooring was identified, VHB's Certified Industrial Hygienist (CIH) collected samples for analysis, performed a Risk Assessment, and found mercury vapor in the indoor air at concentrations exceeding the New Jersey Department of Health (NJDOH) threshold. VHB coordinated with the school district and NJSDA in the abatement design process, performed oversight of the abatement process, and performed final clearance sampling to verify that the mercury hazard had been effectively mitigated and replaced.

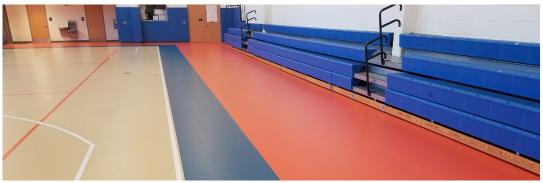
Resilient, multi-use flooring can now be installed without the use of PMA as a catalyst. VHB led the removal and disposal of PMA flooring from this school gym and led the abatement and replacement with safe materials.

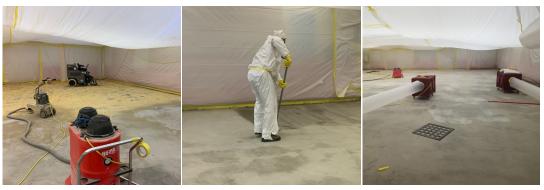
PMA flooring is removed by isolating the work area, monitoring air vapor, dust and debris control, and providing personal protection equipment for workers. Negative-pressure containment and decontamination chambers for personnel, equipment, and waste are utilized to prevent mitigation of mercury vapor or contaminated dust out of the work area.

If the results exceed established thresholds, the CIH will assist in determining the appropriate solution. Possible corrective actions may include vapor mitigation or abatement of the flooring. The only way to permanently eliminate the risk of mercury hazard is to abate the floor, which involves decontamination processes during abatement and the replacement of the floor with a new surface.
